ENGINEERING REPORT

FAA CONTRACT NO. DTFA03-02-C-00044 PHASE 1, CLIN 0001e (TASK 5) - REMOVAL OF SPECIMENS REPORT

This report documents the physical disassembly of retired aircraft N474DA to remove specimens for destructive evaluation. The objective of the disassembly was to remove the target structures required for evaluation without subjecting them to puncture, overload, or any other damage that would render them unusable for the intended research.

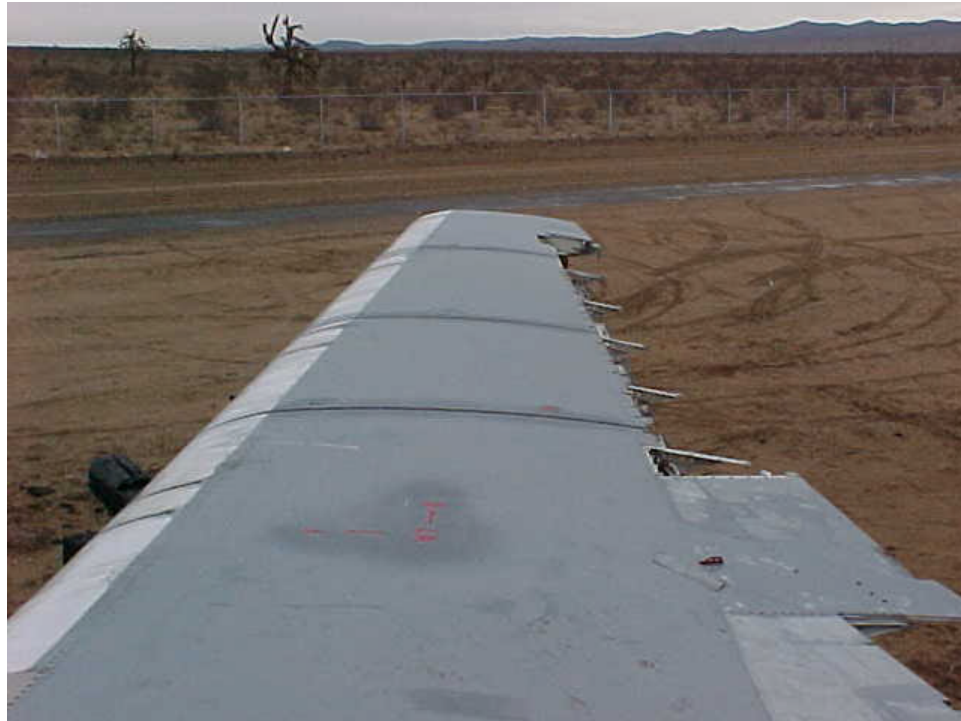
Figure 1: Right Wing Cutlines and W7

Figure 1: Right Wing Cut-lines and W7

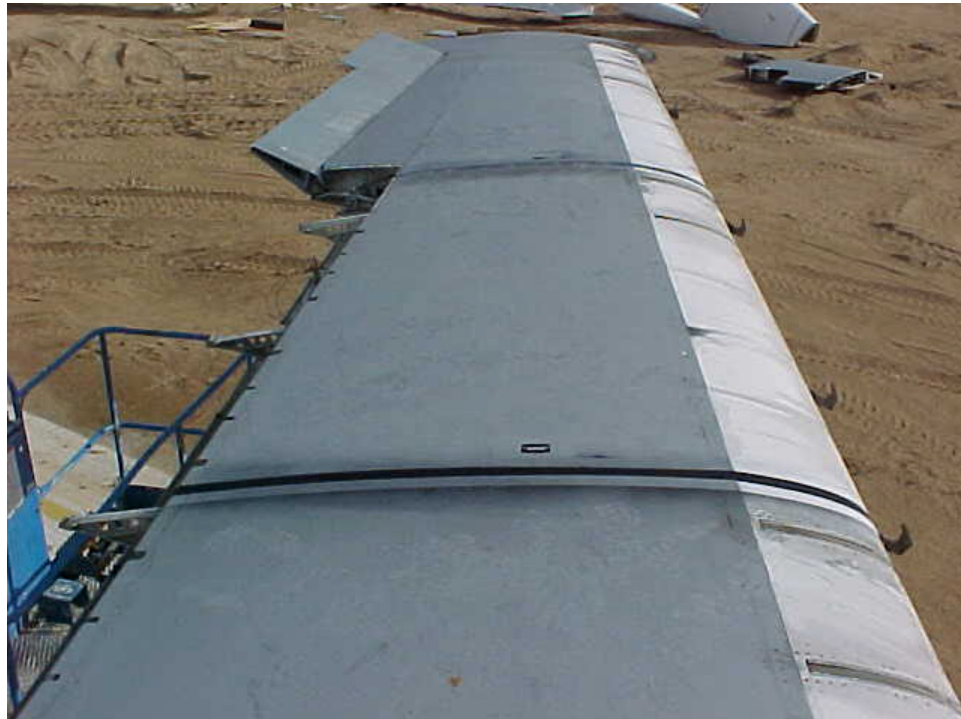
Figure 2: Left Wing Cutlines

Figure 2: Left Wing Cut-lines

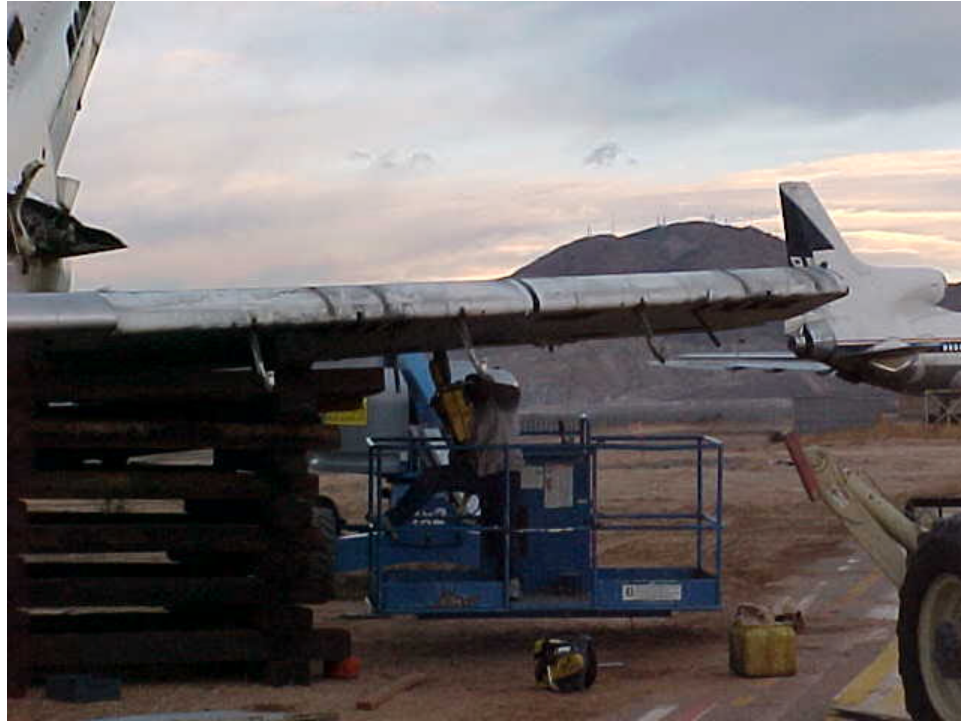
Figure 3: Under-cutting the left wing

Figure 3: Under-cutting the left wing

- at the keel beam, under the centerwing
- under the aft fuselage
- Removed W6
 - Cut along the lower surface first, followed by spar webs.
 - Access holes cut into leading edge to cut anti-icing ducts and control cables
 - Support W6 with forklift
 - Cut upper surface
- Cut F, removing wing outboard of W7
- Related Figures:
 - Figure 4: Preparing to lift left wing shoring under W6
 - Figure 5: Supporting outer wing while stacking new shoring inboard of W6
 - Figure 6: Stacking new right wing shoring inboard of W7

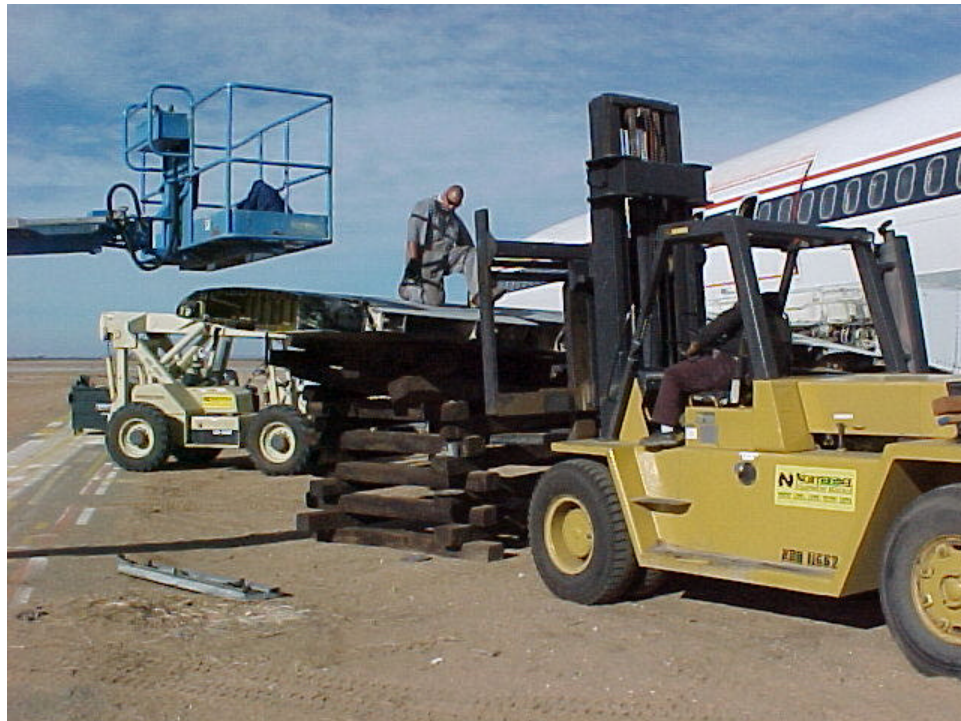
Figure 4: Removing left wing shoring from under W6

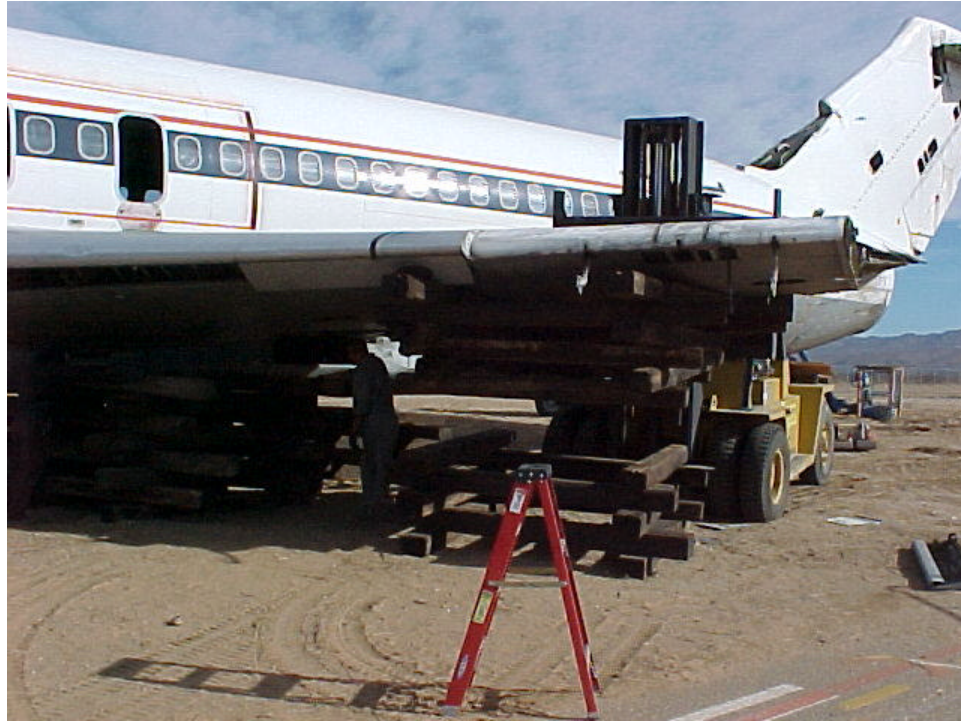
Figure 5: Supporting W6 prior to upper cut

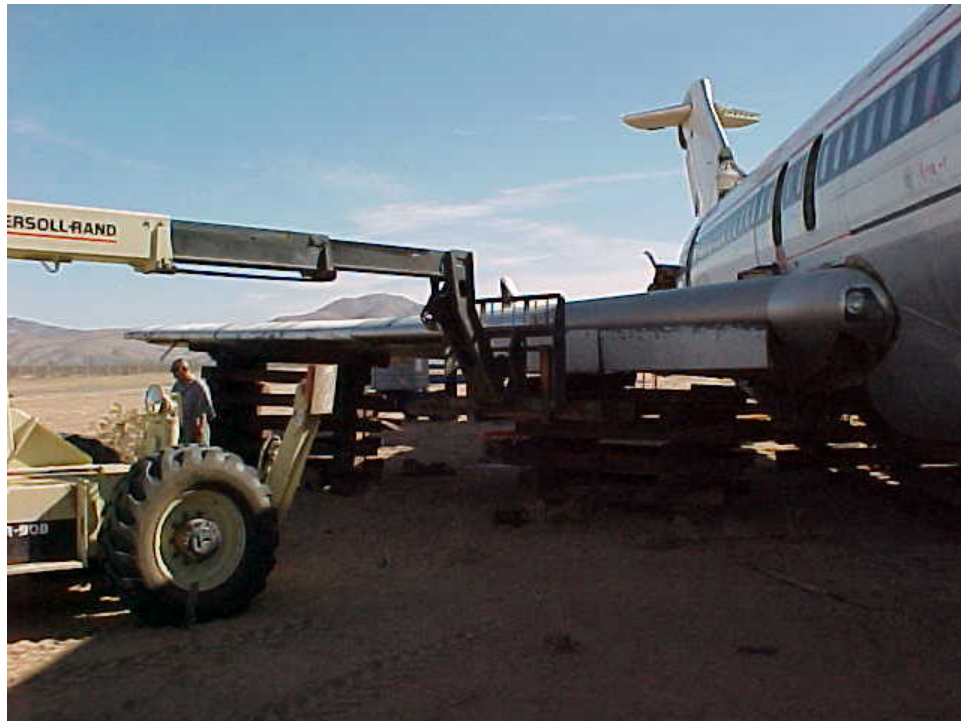
Figure 6: Stacking new right wing shoring inboard of W7

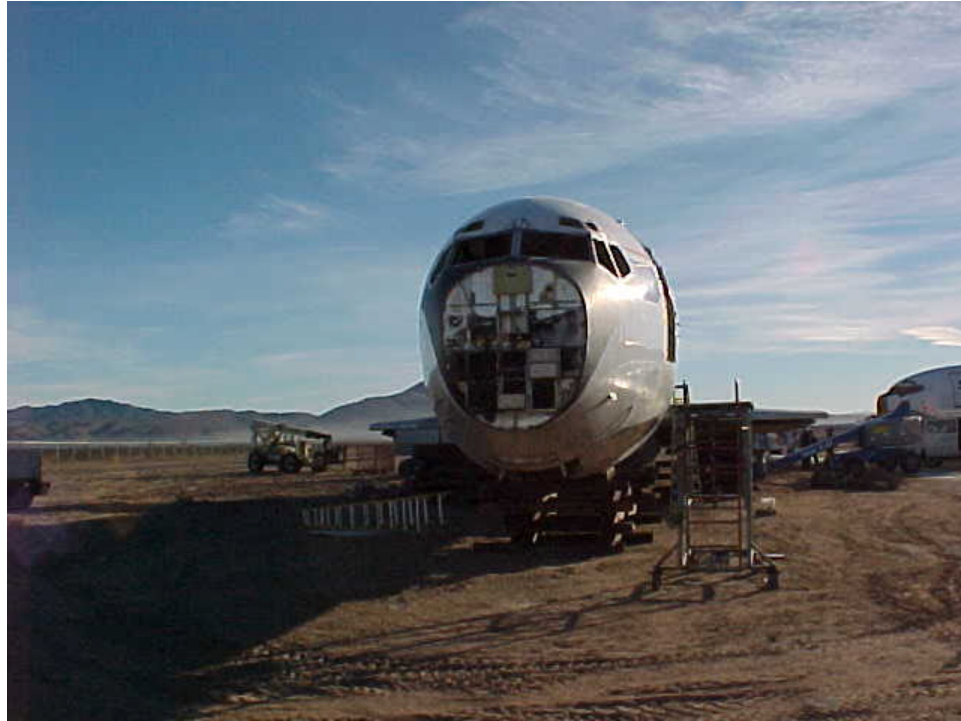
Figure 7: W7 removed

Figure 7: W7 removed

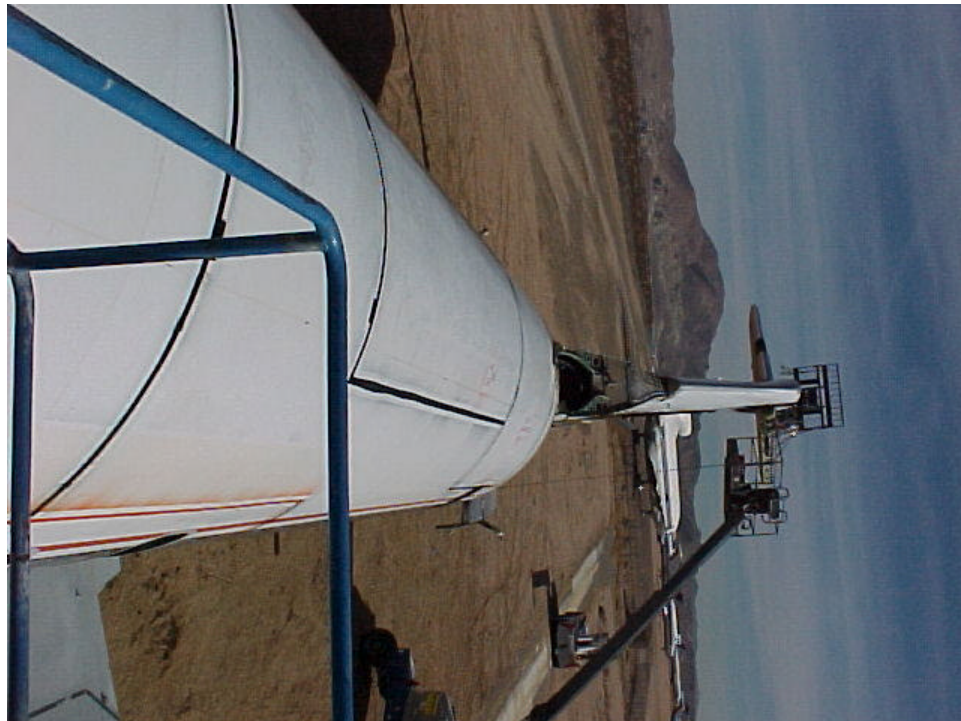
Figure 8: Removing the outer sections of the horizontal stabilizer

Figure 8: Removing the horizontal stabilizer trim actuator

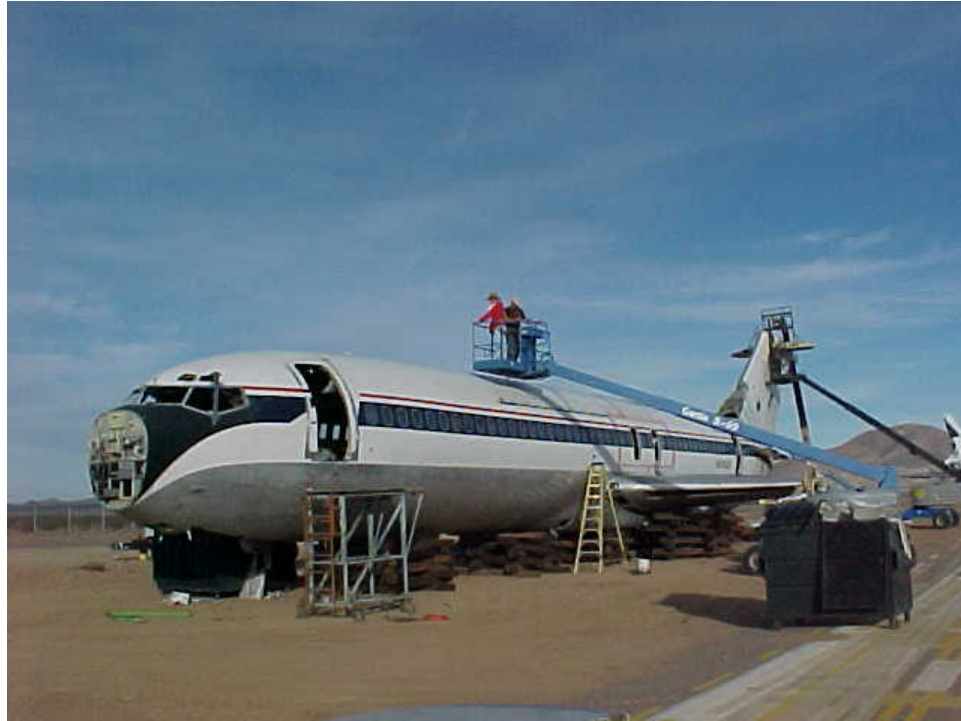
Figure 9: Painting the fuselage crown cut lines

Figure 9: Painting the fuselage crown cut lines

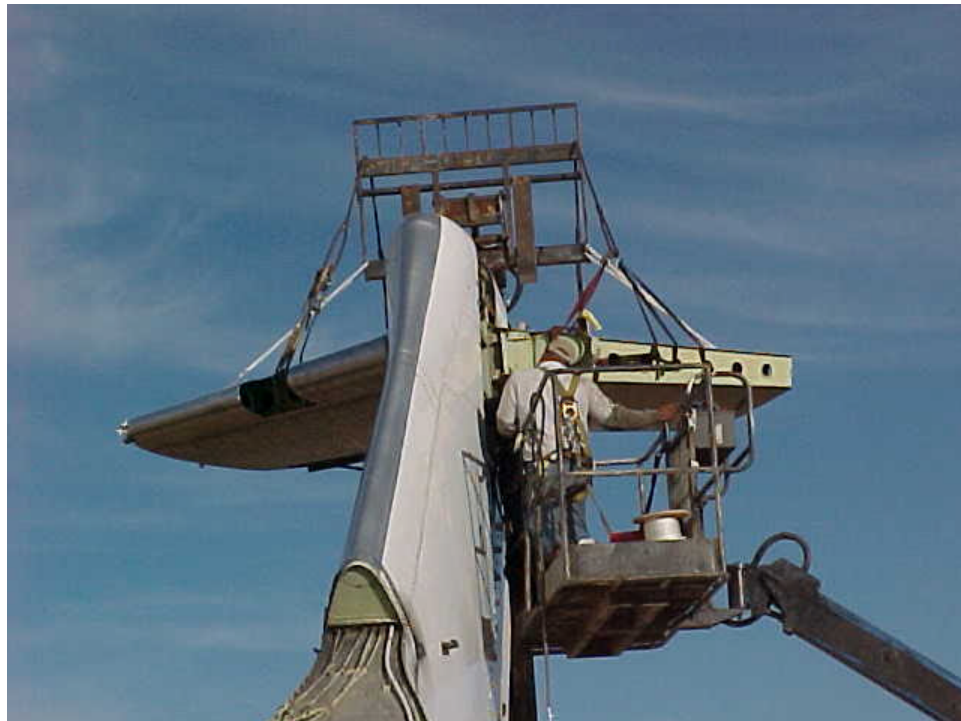
Figure 10: Supporting the H1 and H2 prior to removal

Figure 10: Supporting the H1 and H2 prior to removal

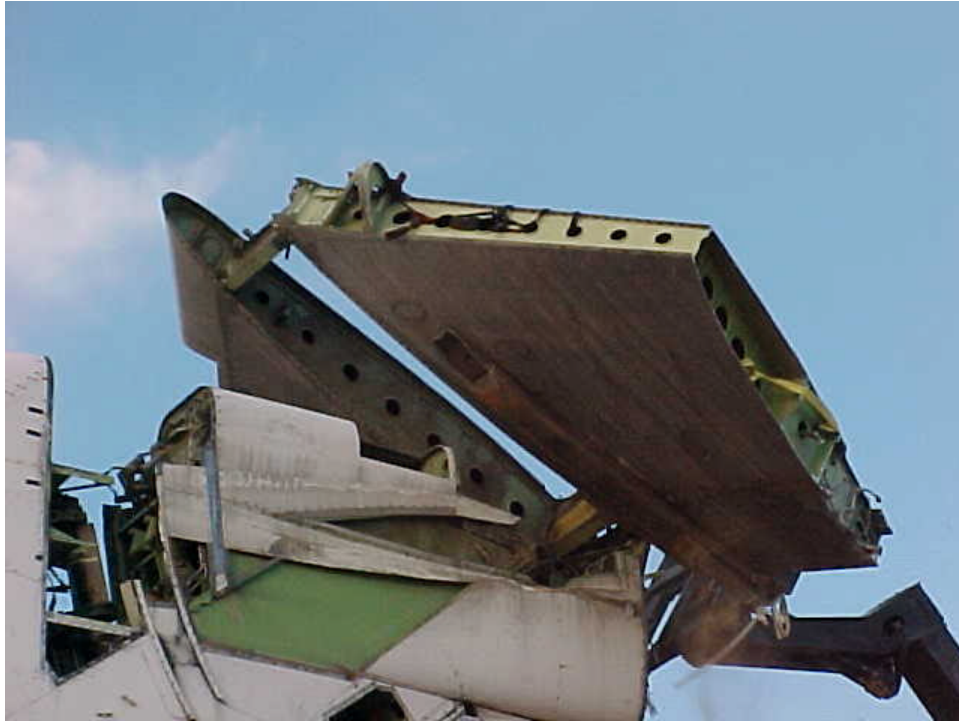
Figure 11: H1 and H2 lifted from vertical stabilizer

Figure 11: H1 and H2 lifted from vertical stabilizer

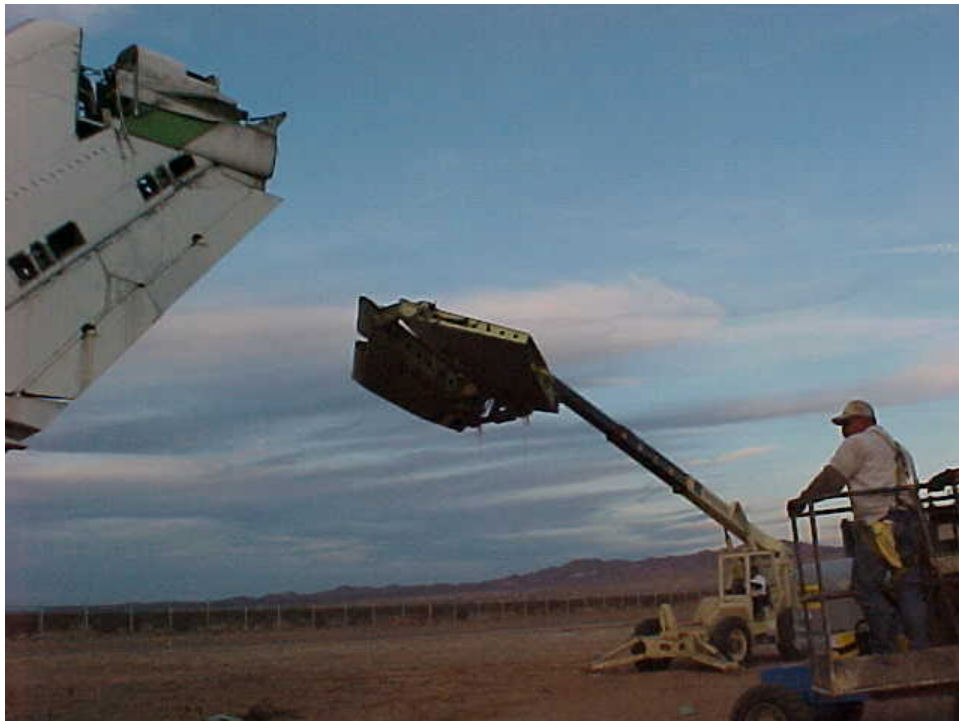
Figure 12: H1 and H2 lowered to ground

Figure 12: H1 and H2 lowered to ground

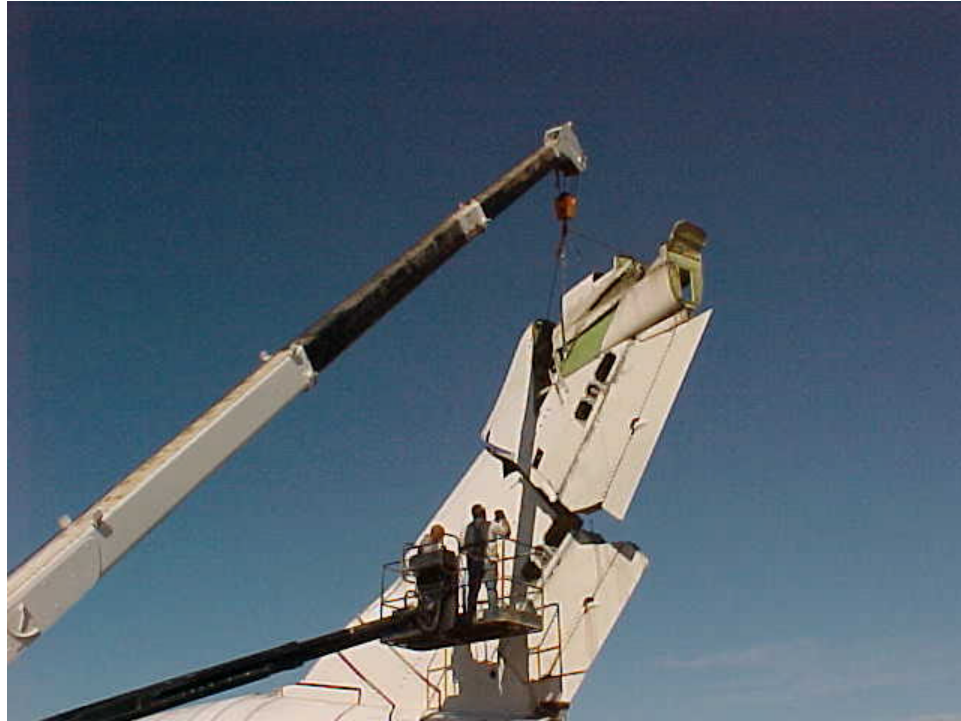
Figure 13: First of three vertical stabilizer sections removed

Figure 13: First of three vertical stabilizer sections removed

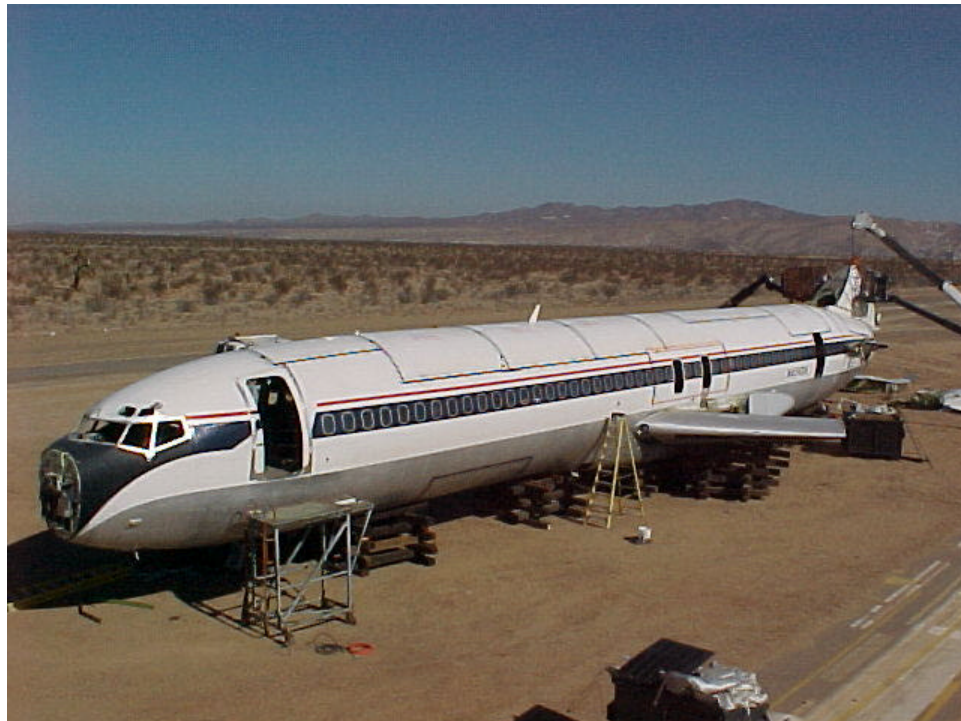
Figure 14: Painted cut-lines finished

Figure 14: Painted cut-lines finished

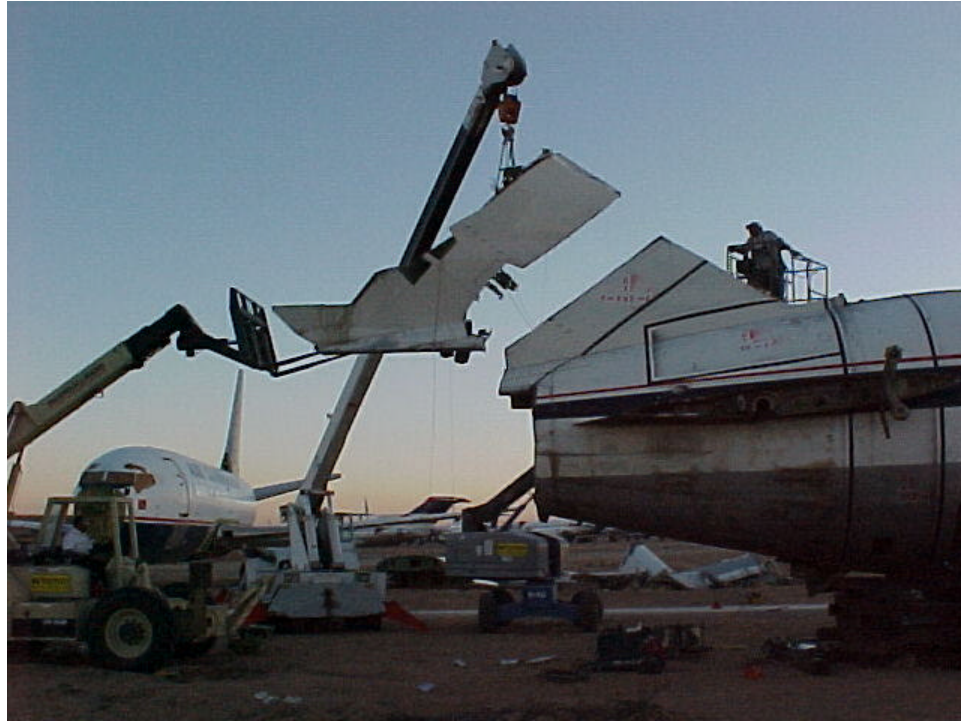
Figure 15: Last vertical fin section above FN1/FN2 removed

Figure 15: Last vertical fin section above FN1/FN2 removed

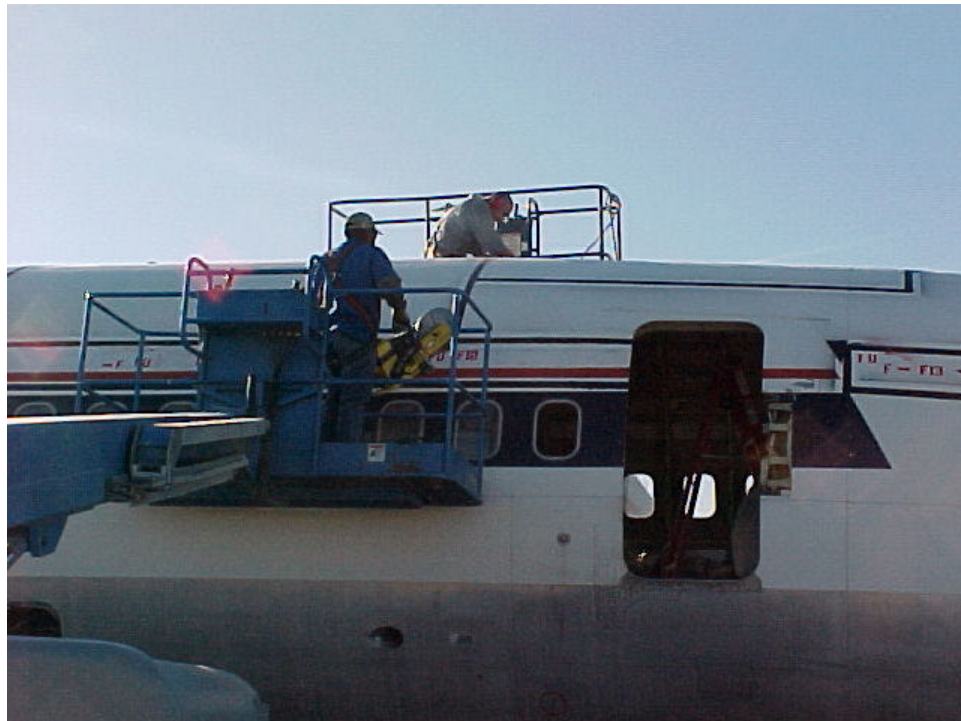
Figure 16: Start crown panel cuts

Figure 16: Start crown panel cuts

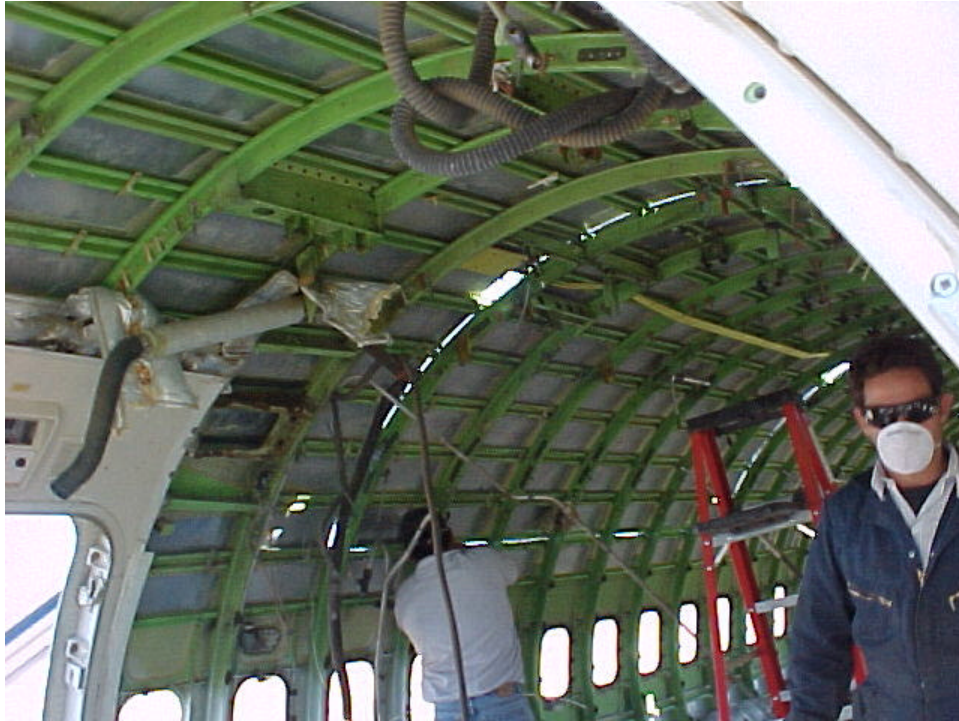
Figure 17: Lifting straps between S-3 and S-4

Figure 17: Lifting straps between S-3 and S-4

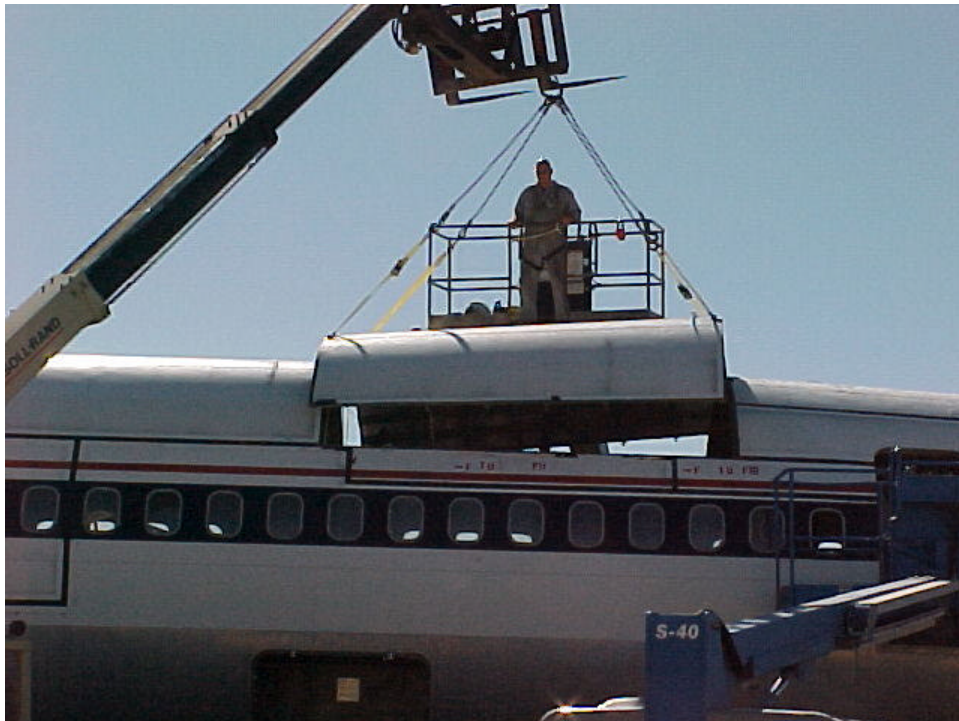
Figure 18: F3/FT1 removed

Figure 18: F3/FT1 removed

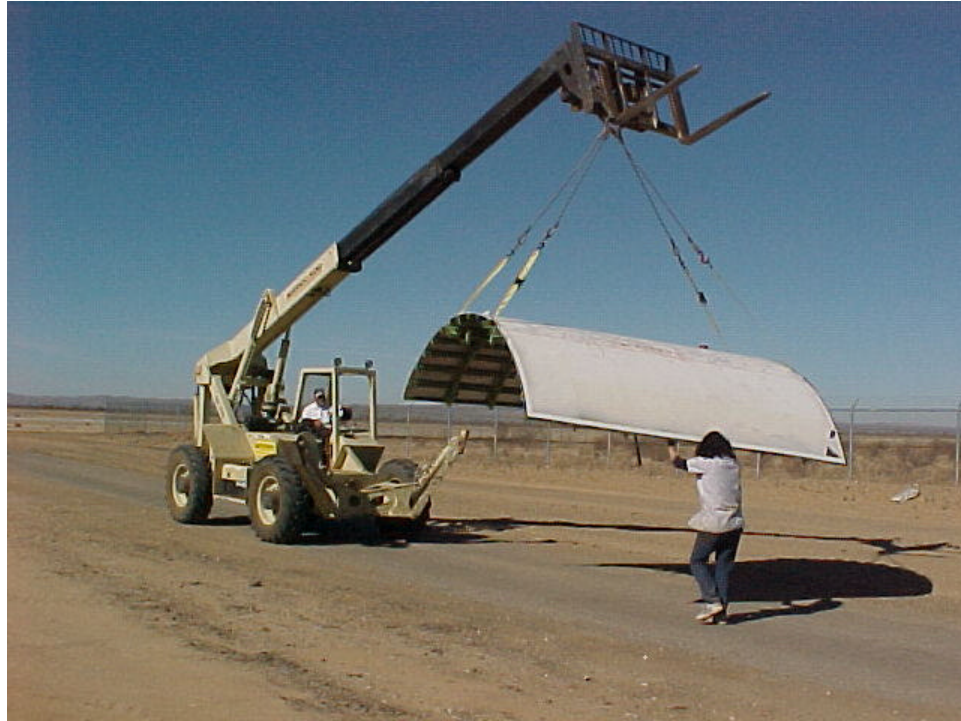
Figure 19: F3/FT1 guided to staging area

Figure 19: F3/FT1 guided to staging area

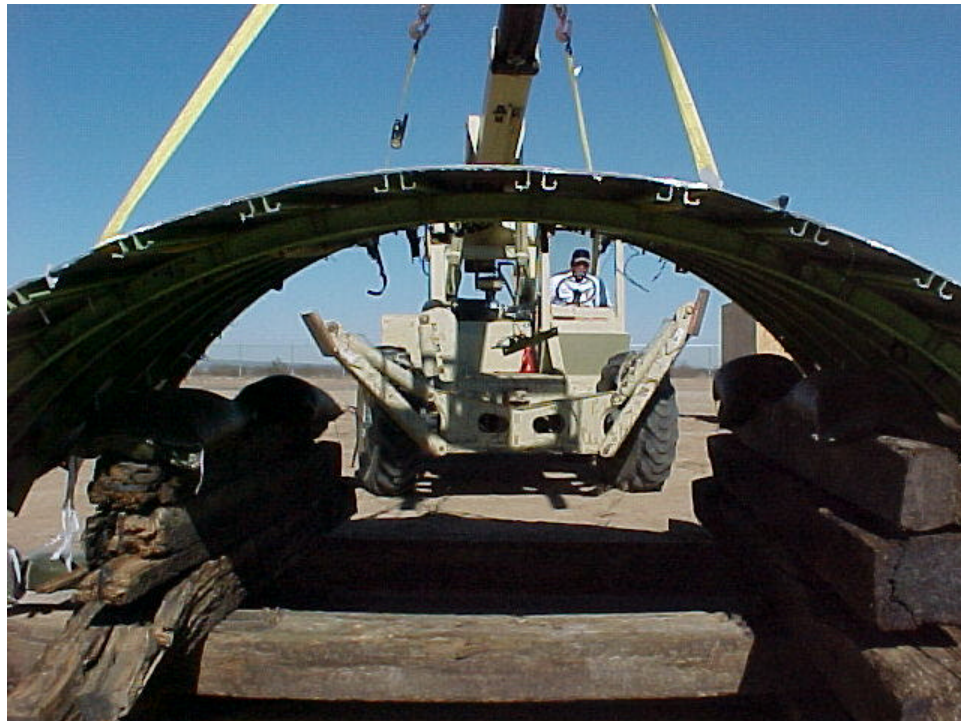
Figure 20: F3/FT1 lower onto staging ties

Figure 20: F3/FT1 lower onto staging ties

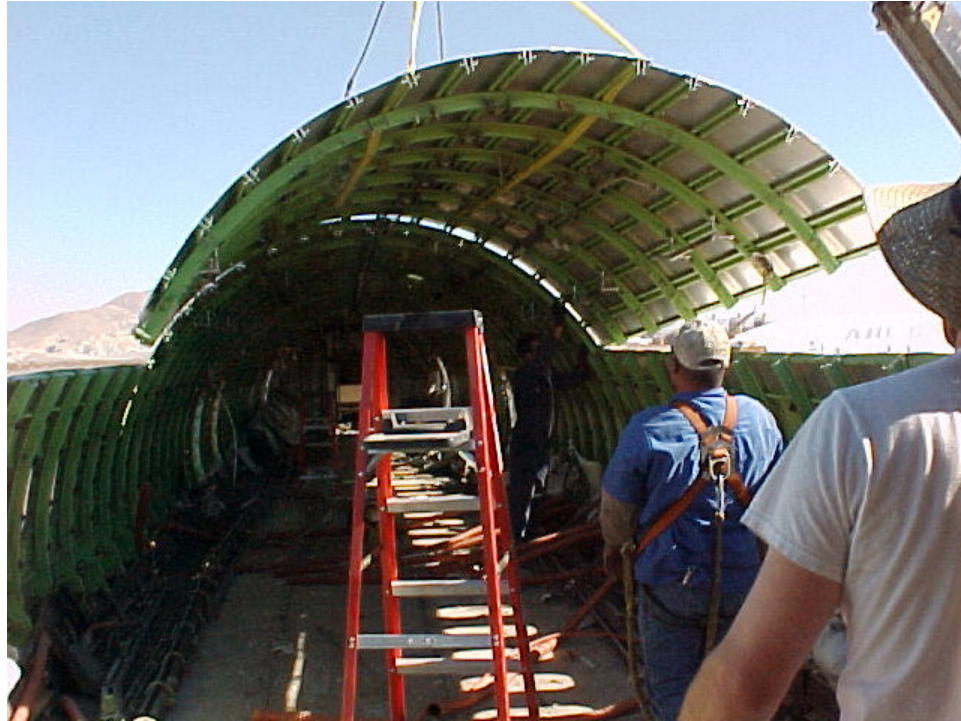
Figure 21: F4/FT2 removed

Figure 21: F4/FT2 removed

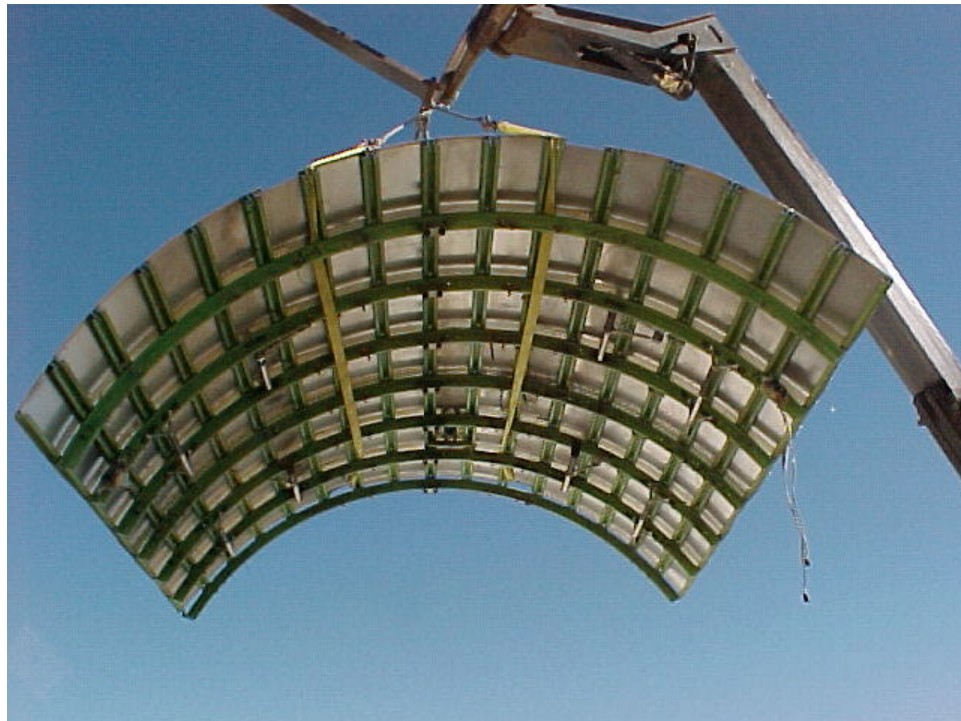
Figure 22: Lift point uses stringer centerline

Figure 22: Lift point uses stringer centerline

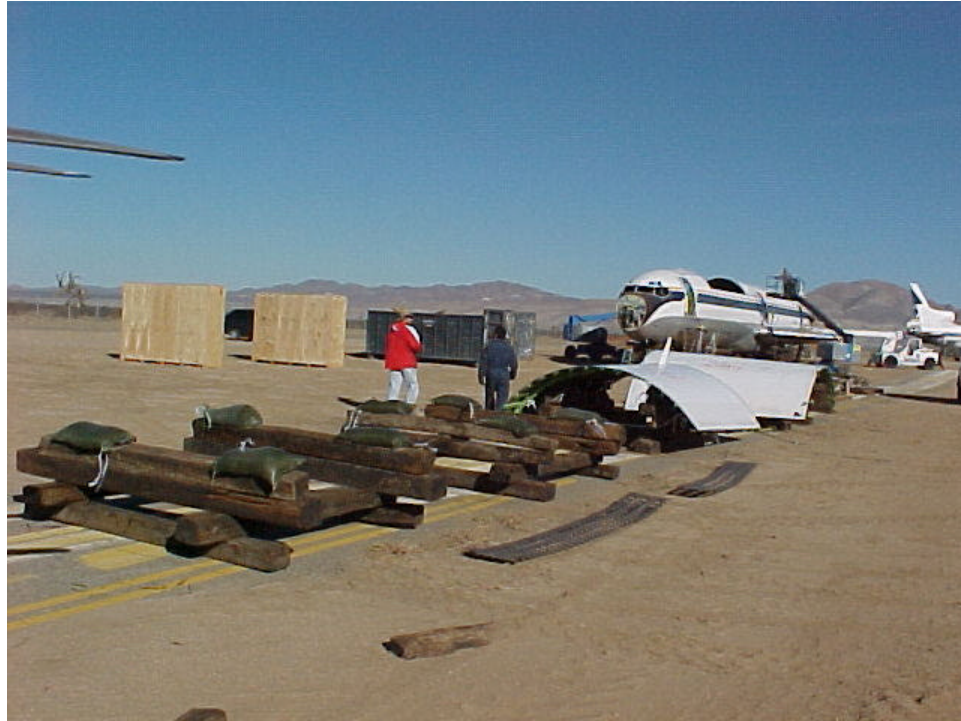
Figure 23: Staging area for 4 large crown panels

Figure 23: Staging area for 4 large crown panels

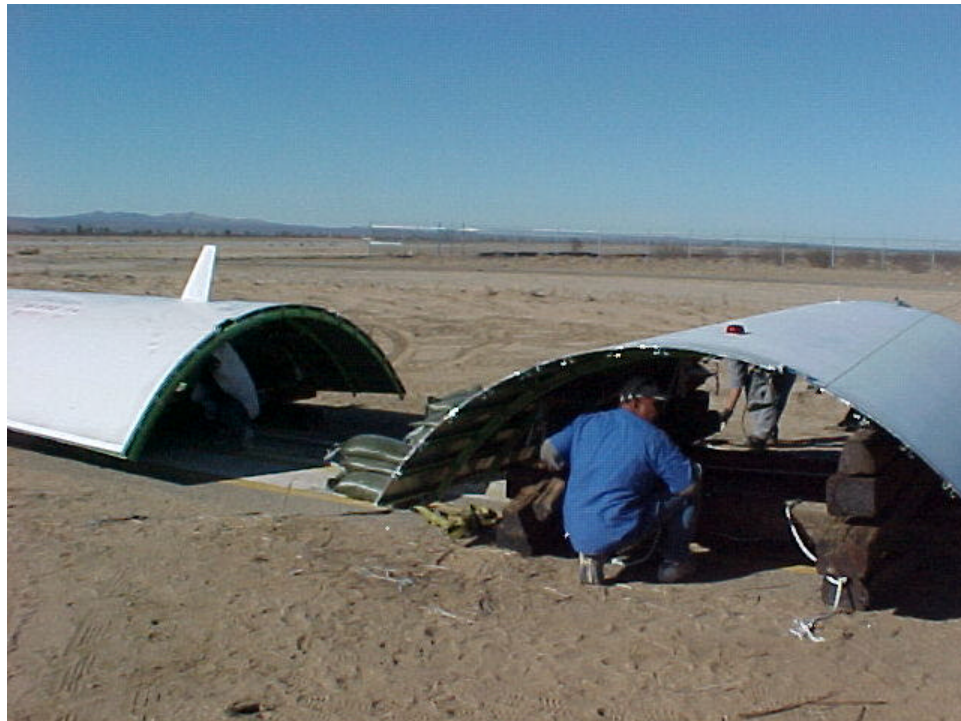
Figure 24: Panels secured to staging ties

Figure 24: Panels secured to staging ties

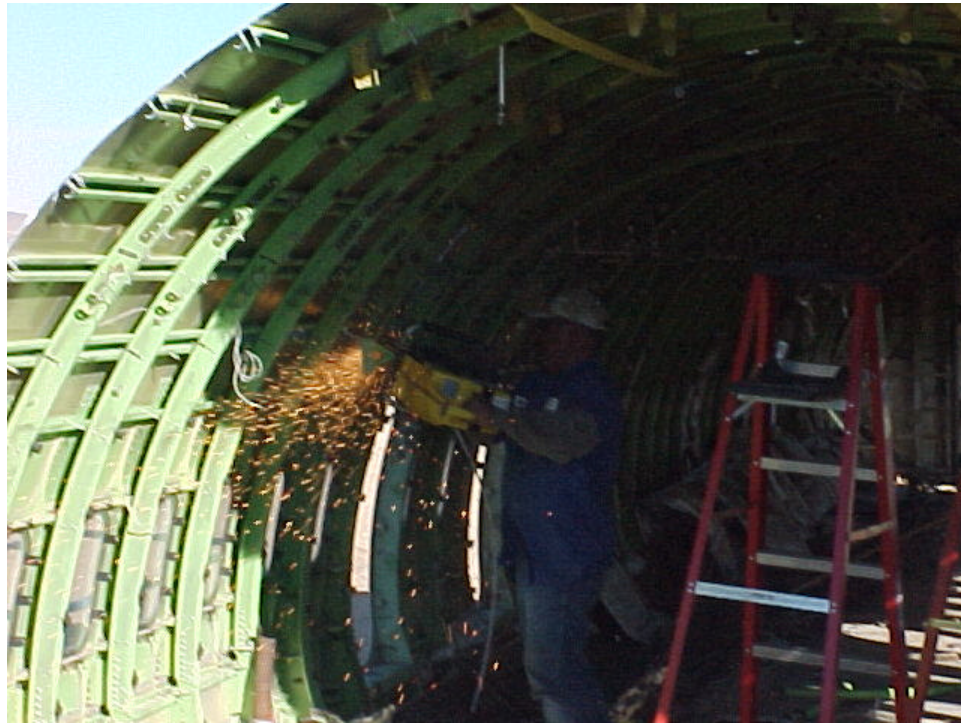
Figure 25: Cutting through steel frame straps for F5/FT3

Figure 25: Cutting through steel frame straps for F5/FT3

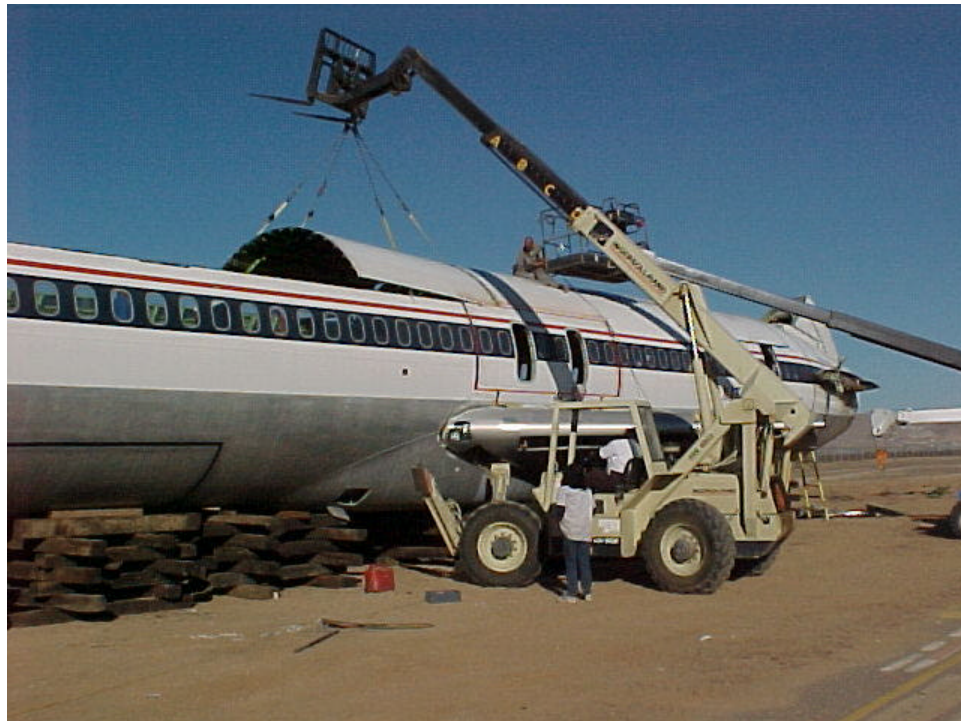
Figure 26: F5/FT3 removed

Figure 26: F5/FT3 removed

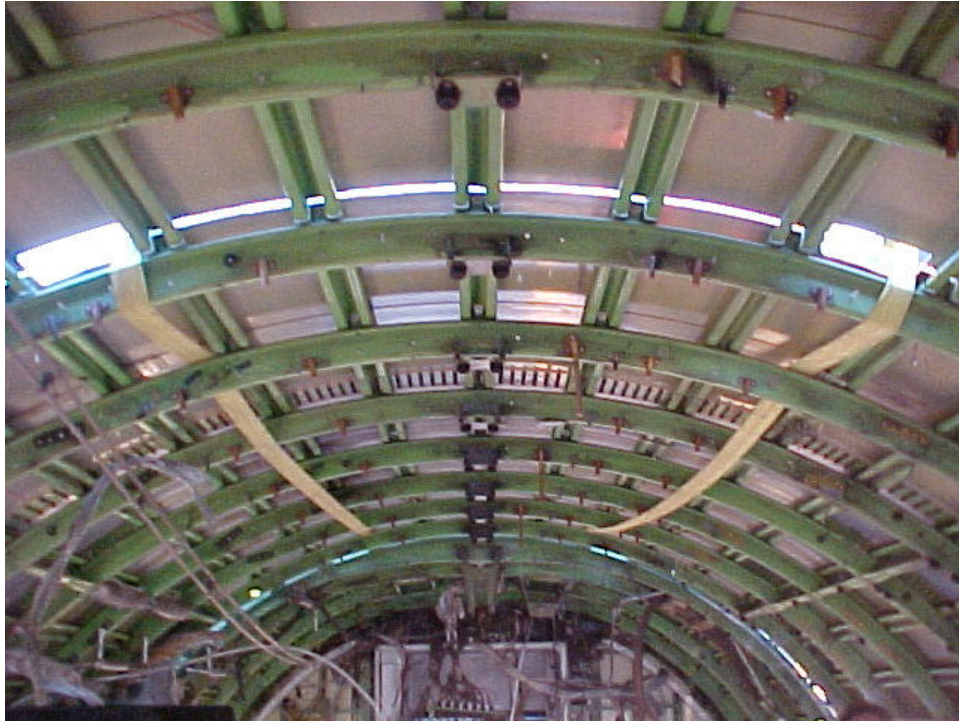
Figure 27: F6/FT4 Ready for lifting

Figure 27: F6/FT4 Ready for lifting

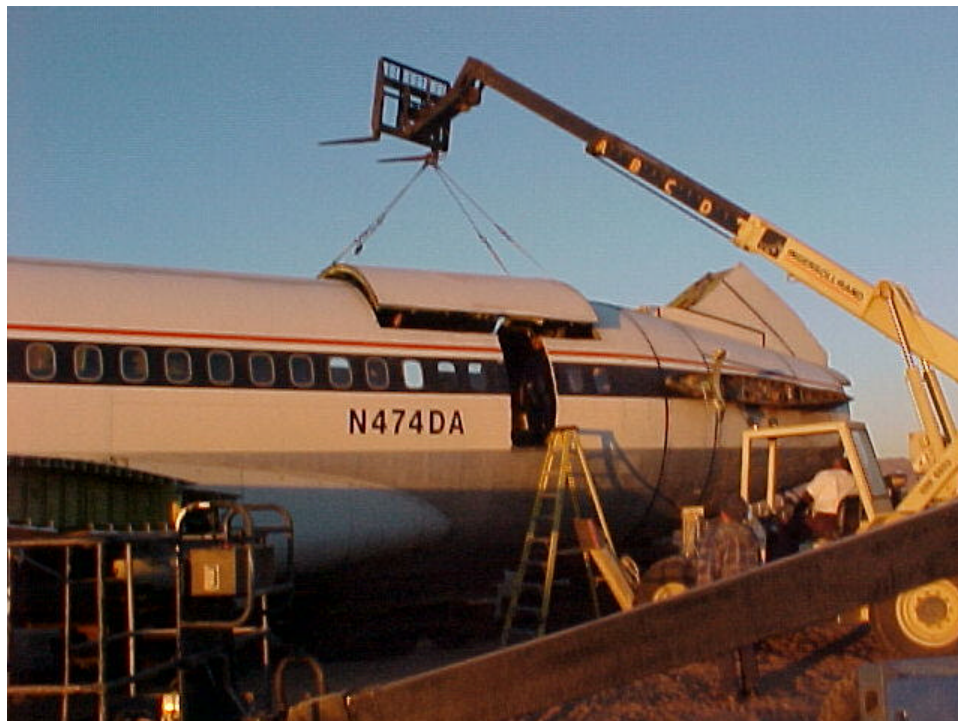
Figure 28: F6/FT4 removed

Figure 28: F6/FT4 removed

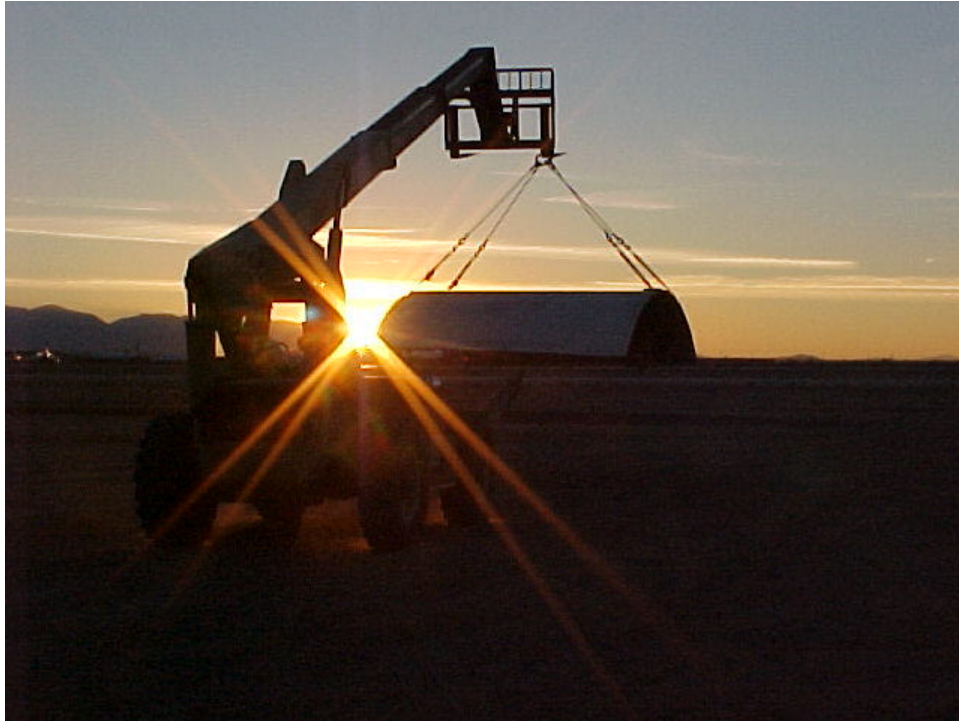
Figure 29: F6/FT4 carried to staging area

Figure 29: F6/FT4 carried to staging area

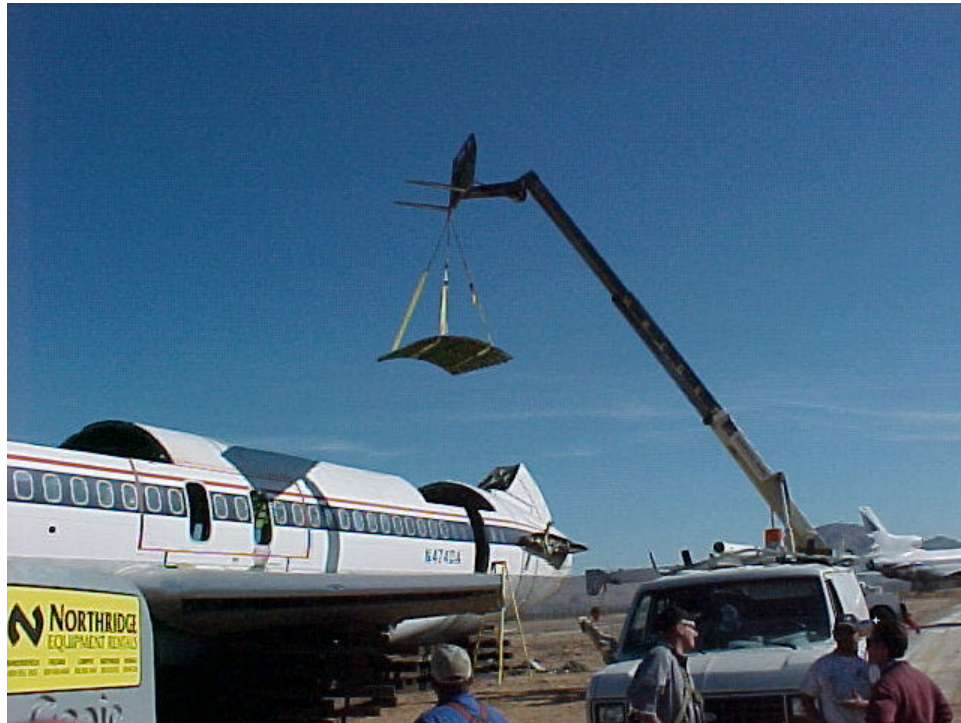
Figure 31: F2 removed

Figure 31: F2 removed

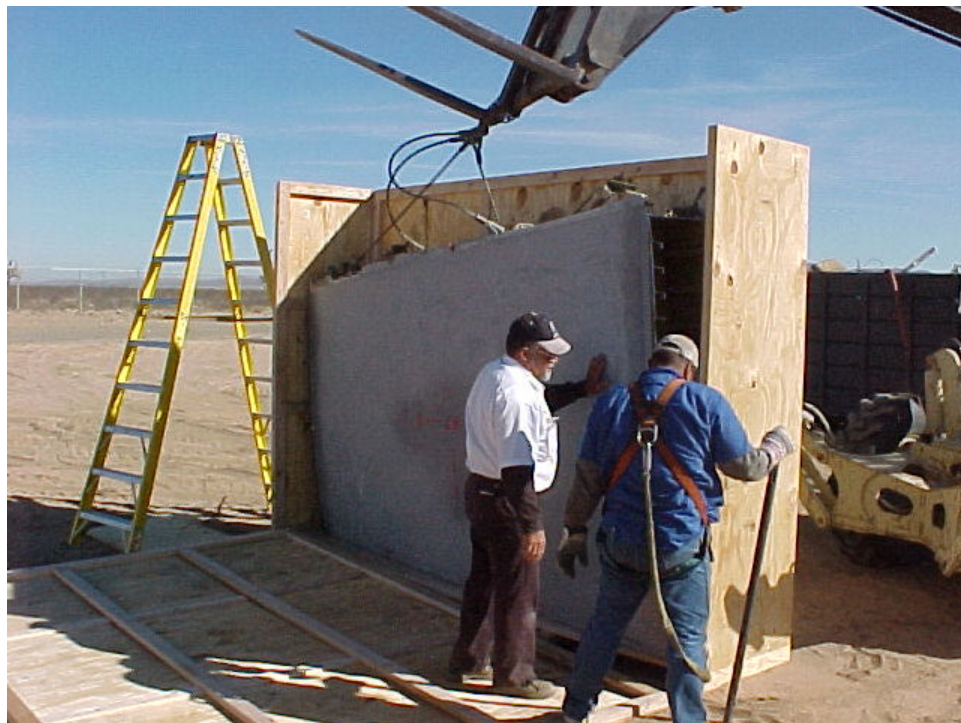
Figure 32: W6 and W7 put into boxes

Figure 32: W6 and W7 put into boxes

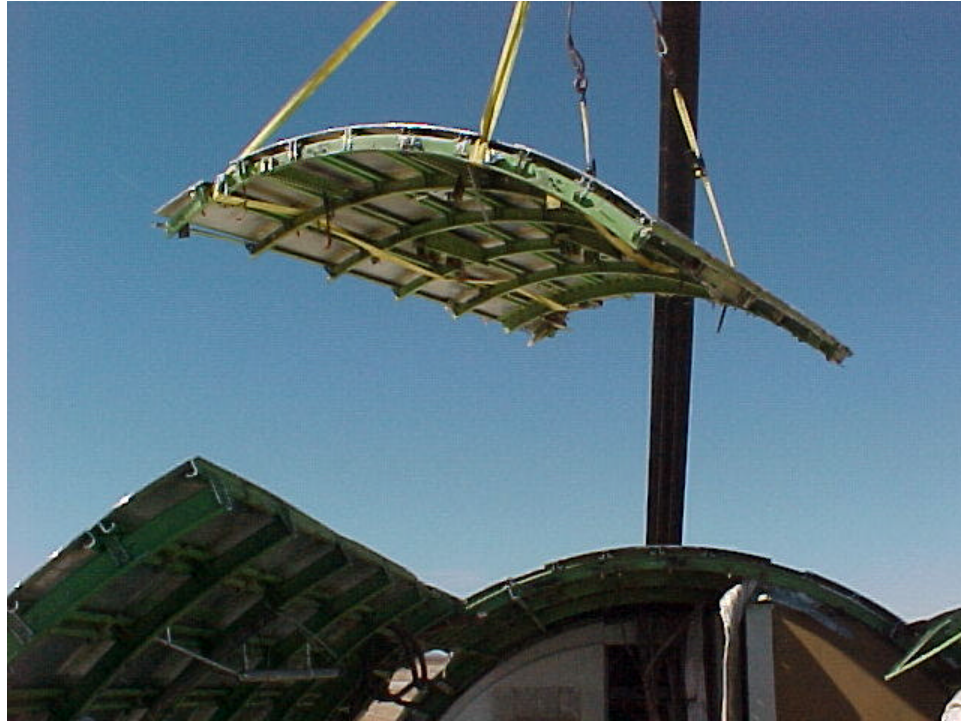
Figure 33: F1 removed

Figure 33: F1 removed
